Quality Assurance and Source Inspection

Contract #: 04-0120F4Cty: SF/ALA Rte: 80 PM: 13.2/13.9File #: 69.28**WELDING INSPECTION REPORT****Resident Engineer:**Pursell, Gary**Address:** 333 Burma Road**City:** Oakland, CA 94607**Report No:** WIR-016050**Date Inspected:** 03-Aug-2010**Project Name:** SAS Superstructure**OSM Arrival Time:** 700**Prime Contractor:** American Bridge/Fluor Enterprises, a JV**OSM Departure Time:** 1900**Contractor:** Zhenhua Port Machinery Company, Ltd (ZPMC), Changxing Island **Location:** Shanghai, China**CWI Name:** Li Yang**CWI Present:** Yes No**Inspected CWI report:** Yes No N/A**Rod Oven in Use:** Yes No N/A**Electrode to specification:** Yes No N/A**Weld Procedures Followed:** Yes No N/A**Qualified Welders:** Yes No N/A**Verified Joint Fit-up:** Yes No N/A**Approved Drawings:** Yes No N/A**Approved WPS:** Yes No N/A**Delayed / Cancelled:** Yes No N/A**Bridge No:** 34-0006**Component:** OBG Trial Assembly**Summary of Items Observed:**

WELDING INSPECTION REPORT

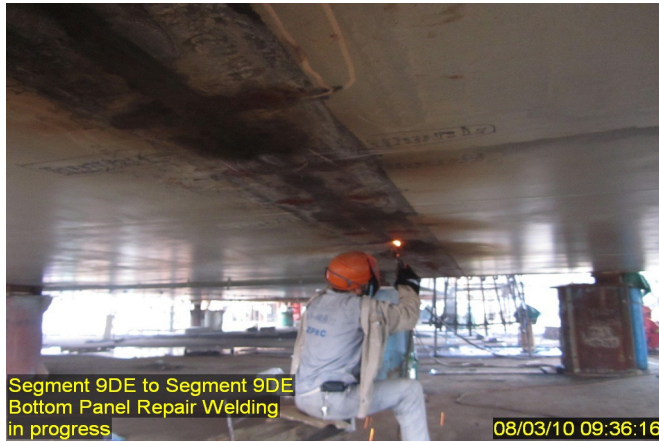
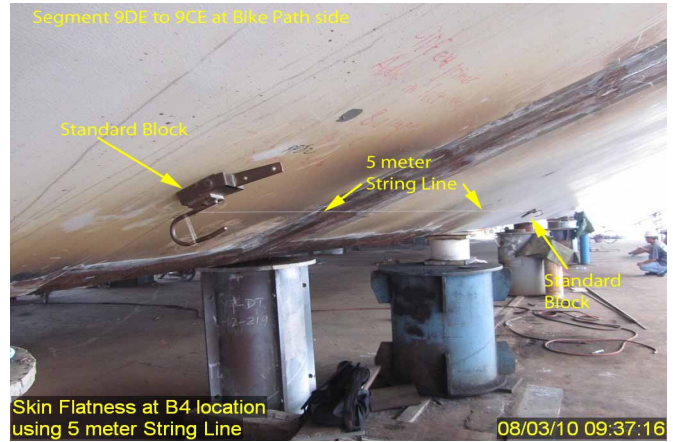
This QA Inspector performed Joint Inspection along with the ABF Survey Team to check the Skin Flatness between Segment 9DE to Segment 9EE between Panel Points (PP) 82 and PP 83 at the following locations:

The skin flatness was measured on North side (Cross Beam side at B1 and B2 location) and South side (Bike Path side at B3 and B4 location) at 100mm from the weld connecting Bottom Panel to Side Panel using 5000mm string line to verify overall flatness. Straight Edges of 600mm and 630 mm of length was also used to measure the localized flatness.

The skin flatness was measured on North side (Cross Beam side at T1 location) and South side (Bike Path side at T2 location) at 100mm from the weld connecting Deck Panel to Edge Panel using 5000mm string line to verify overall flatness. The Straight Edge of 600mm and 630 mm length was also used to measure the localized flatness.

Joint Penetration (CJP) groove weld. The Weld joint was designated as OBE9C-008. The welder identification was 048659 and observed welding in the 4G (Vertical) position using approved Welding Procedure Specification WPS-345-SMAW-4G (4F)-FCM-Repair-1. The piece mark was identified as Bottom Panel transverse splice. ZPMC performed repair welding in accordance with CWR-1736. Please reference the pictures attached for more comprehensive details.
